# Repair, Restoration And Retrofitting of Masonry Buildings with ADO's Convac System

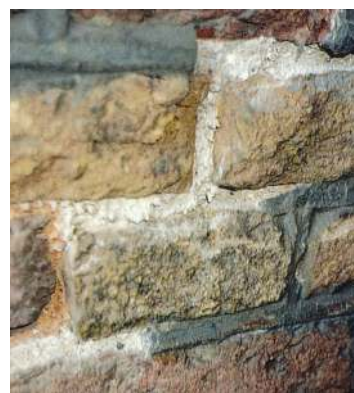
Push-out of cement re-pointing due to crystallization of salts at the interface of new pointing and old bedding mortar.

important damage causing salt is sulphates (for example  $\text{Na}_2\text{SO}_4$ ) and chlorides (for example  $\text{NaCl}$ ). Salts precipitating in the pores of a mortar may create pressures, which may lead to damage. As a consequence of salt crystallization, a mortar can show damage in the form of sanding, scaling, exfoliation or crumbling, whereas the masonry units may show damages like powdering, exfoliation and spalling. Sometimes salt crystallization causes damage to a lime bedding mortar because a physically incompatible pointing mortar was chosen. This is the case of a too dense pointing applied on a more porous lime mortar. Because of the hindering of the drying caused by the new cement pointing, crystallization of salts that were already present in the masonry occurs at the bedding mortar-pointing interface. This results in the detachment of the pointing (also called push-out) and also in a form of loss of cohesion (crumbling or sanding) of the underlying lime bedding mortar.

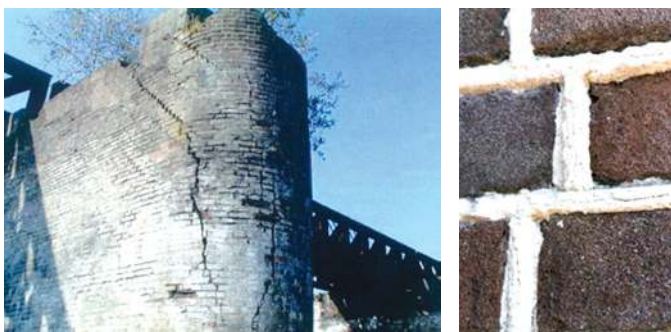
(a) Crack pattern in masonry, looking like structural damage but caused by expansive reaction in the internal part of the mortar; (b) Bursting of pointing mortar due to the formation of  $\text{CaO} \cdot \text{Al}_2\text{O}_3 \cdot 3\text{CaCl}_2 \cdot 31\text{H}_2\text{O}$  (trichloride).

Apart from pure crystallization, the formation of expansive compounds due to the reaction of salts with mortar components may also cause considerable damage, not only to mortars, but to the masonry as a whole. Sometimes the resulting crack patterns may be mistaken for structural damage, where only after drilling cores from the masonry it becomes clear that the cracks originated from swelling of the mortar inside the pier. Additional

investigations with optical and electron microscopy revealed the presence of secondary ettringite concentrations, initiating the cracks. Sometimes the pointing mortar is bursting, i.e. it looks like it swells because of an increase of volume. In this last example, the damage in the form of bursting of the pointing was shown to be due to the formation of trichloride.
